**2008 Historic Resource Survey
North Side, City of Granbury**

**Property No.: 117
500 East Moore**

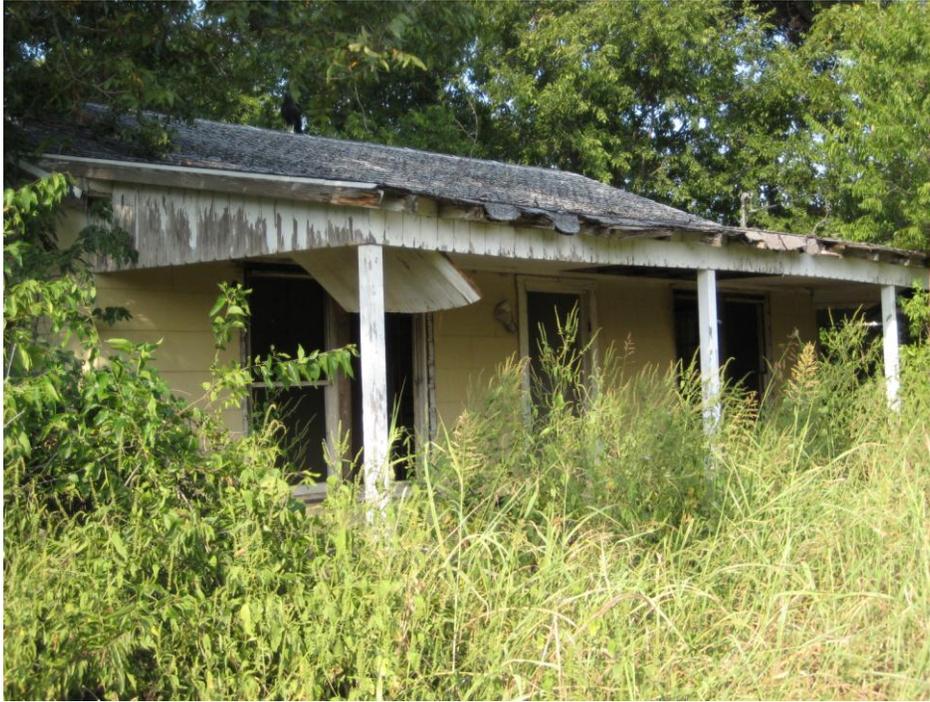
Frame construction, asbestos siding
Gable roof, composition shingles
Double-hung, wood windows
Single-door primary entrance
Shed roof porch, wood posts
Center passage plan
Pier and beam foundation
One story, 1,190 square feet

Location, setting

Neglect, development, vacancy
