**2008 Historic Resource Survey
North Side, City of Granbury
Property No.: 142
801 Stockton Bend Road
Nutt-Randle Farmhouse**

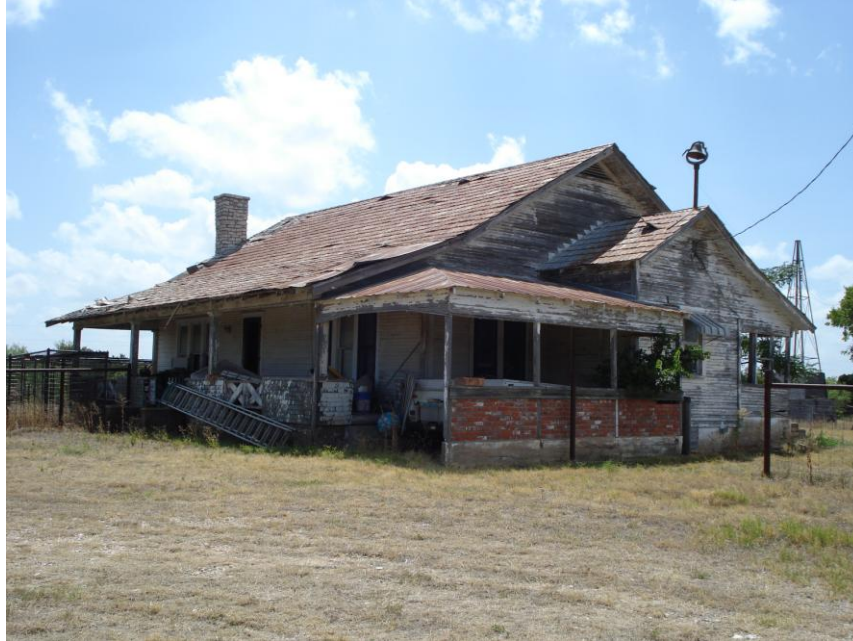
Frame construction, wood siding

Gable roof with wood shingles and metal, exposed rafter tails

Two chimneys—one interior brick and one exterior stone

Double-hung wood windows, Single door primary entrance

Shed roof porch, box columns resting on frame piers with shingles

Center passage plan, pier and beam foundation

One and a half stories, 1,357 square feet

Situated on large piece of land atop hill along south side of Stockton Bend Road between city and original settlement of Stockton. Property includes well/cistern, windmill, concrete trough, metal fencing, barbed wire and cedar post fence, two barns, two sheds, two mobile homes, a carport and storm cellar built by “Uncle Frank” Thorp. Old dinner bell still hangs over deteriorating farmhouse, which is open to the elements. Carport added on west end, sleeping porch in rear. East end has a second-floor door and wood staircase leading up to it.
